Summary

1. When we measured the effective rms of the surface on scales of less than a meter using scans of the moon we found a larger value than expected.
2. Doing “astro-holography” – interferometric beam scans with a planet as the source – showed that there were indeed errors.

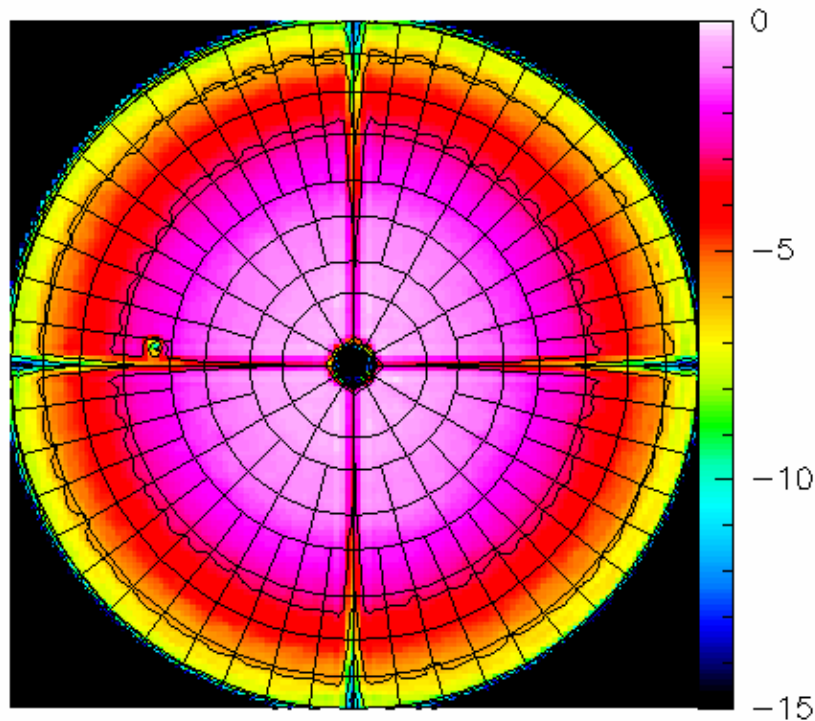
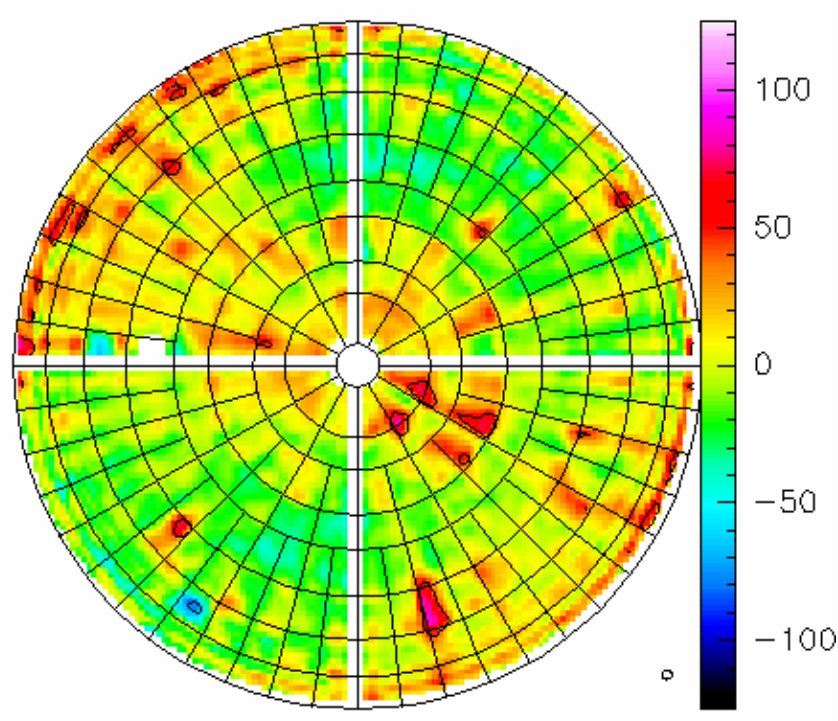
- DV01 at OSF 24 Aug 2010 “tower holography”

4. DV01 was brought down and it was again confirmed with “tower” holography that there were significant errors. Rms surface contribution was about 13 microns.

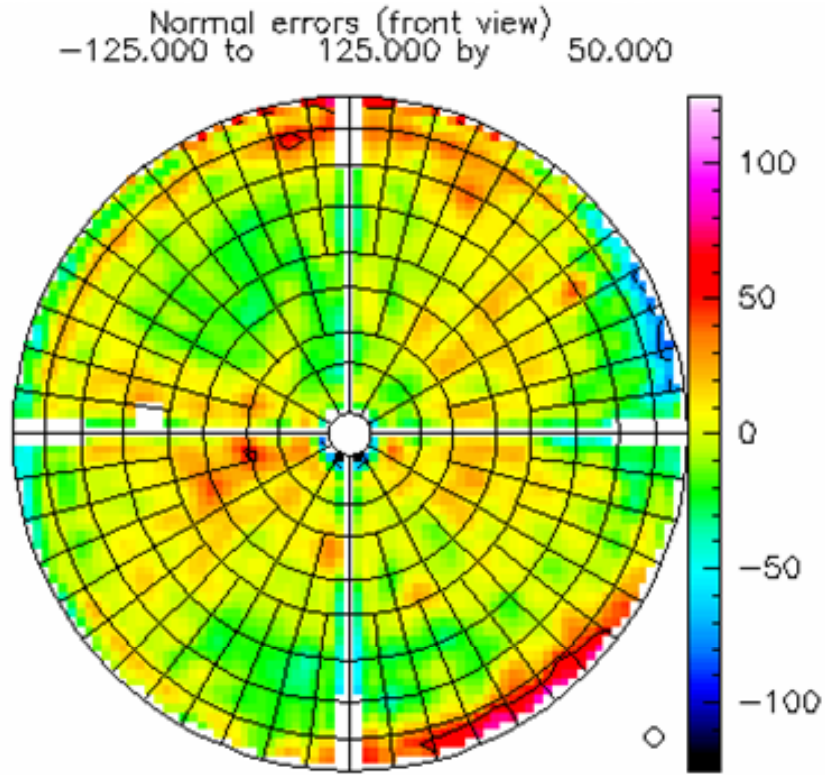
• DV02 04 June 2010 (AOS)

Map has lower resolution

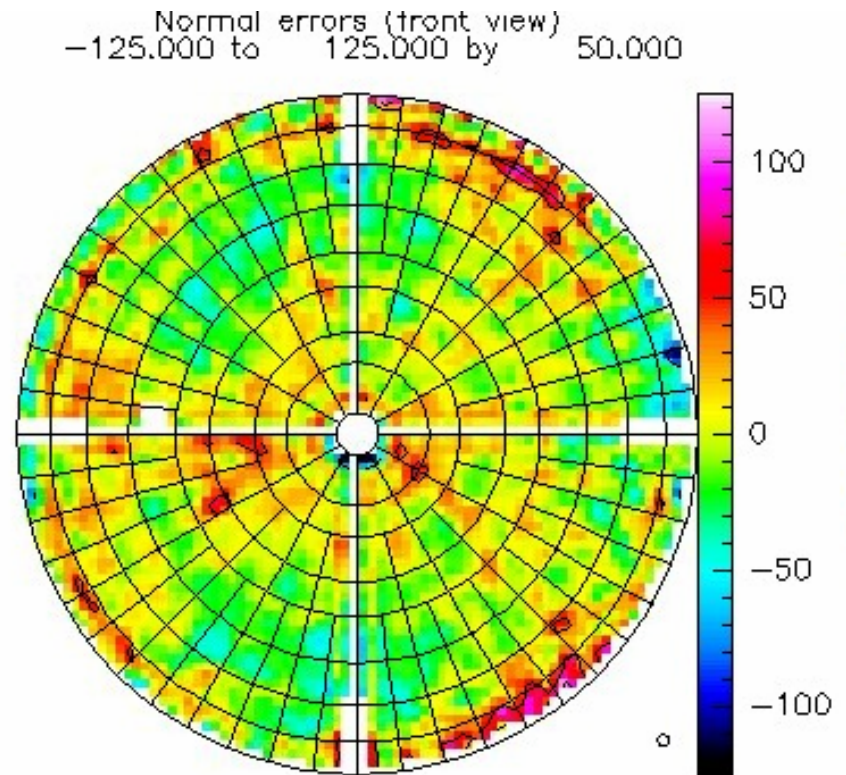
30 Aug 2010 (AOS)

3. When DV02 was brought down for servicing this was confirmed and the surface was readjusted. After a few weeks back at the high site it looked as if errors were appearing again.

Map somewhat noisy

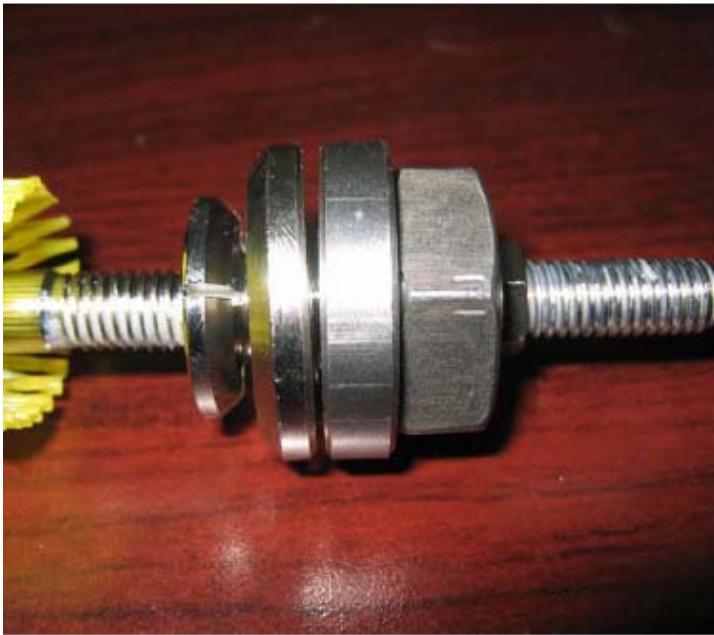
Rough adjustment Z- Adjuster
(screwed into the BUS)

5. Investigations showed that some of the nuts where the adjusters are attached to the backing structure were loose. More importantly that the ones where there were errors had been over-tightened and that this had damaged the locking mechanism

- The effect appears to have been caused by damage to the anti-slip devices on the bolts that attach the adjusters to the Back-up Structure. It appears that these have been over-tightened.

6. The damaged ones have been replaced and we will monitor DV01 after it goes back up
7. The other Vertex antennas will have to be fixed at some future time.

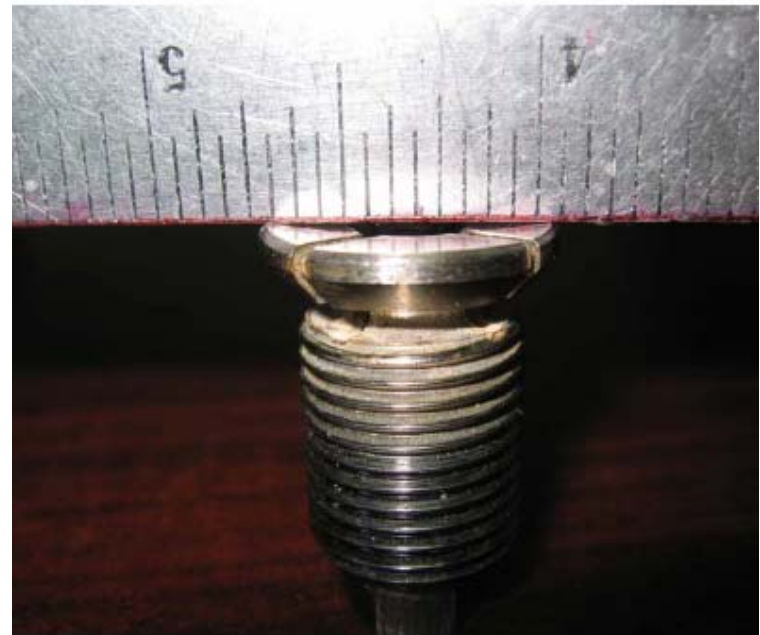
Overstressed clamp
